Thermography finds leaks in district heating networks

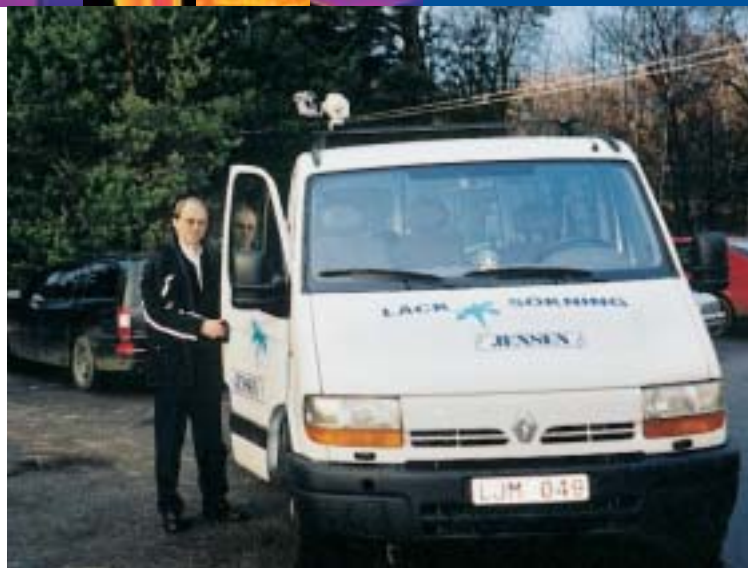
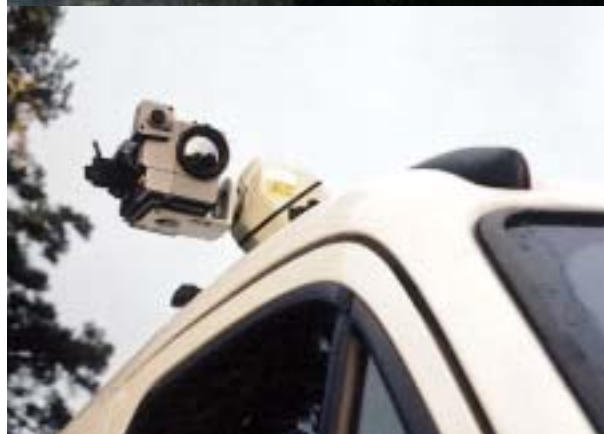
Arne Jensen AB has developed ever better techniques for checking district heating networks. Among other things, they have produced a solution in which the thermal camera is mounted on the roof of a vehicle and is controlled from a special panel inside the vehicle.

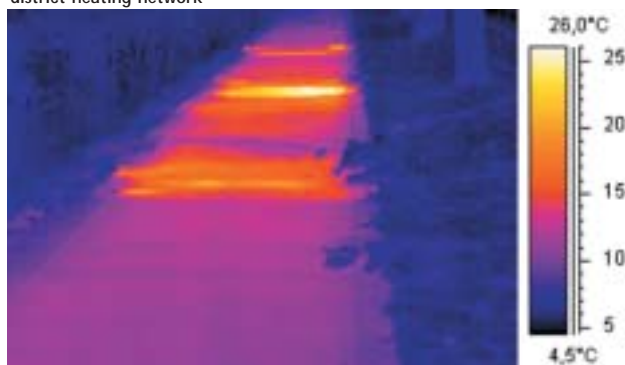
The Infrared image clearly shows a leak in the underground district heating network

Using thermography on a district-heating network involves scanning the network from the ground with a thermal camera. The inspections can be carried out at night when there is less traffic. Additionally, temperature differences are even more visible at night because it is generally cooler. The thermal images produced by the camera clearly show the location of temperature rises, which may indicate that heated water has spread into the insulation, or into the ground. Since the thermal images locate leaks extremely accurately, they are an invaluable resource when the time comes to dig and repair.

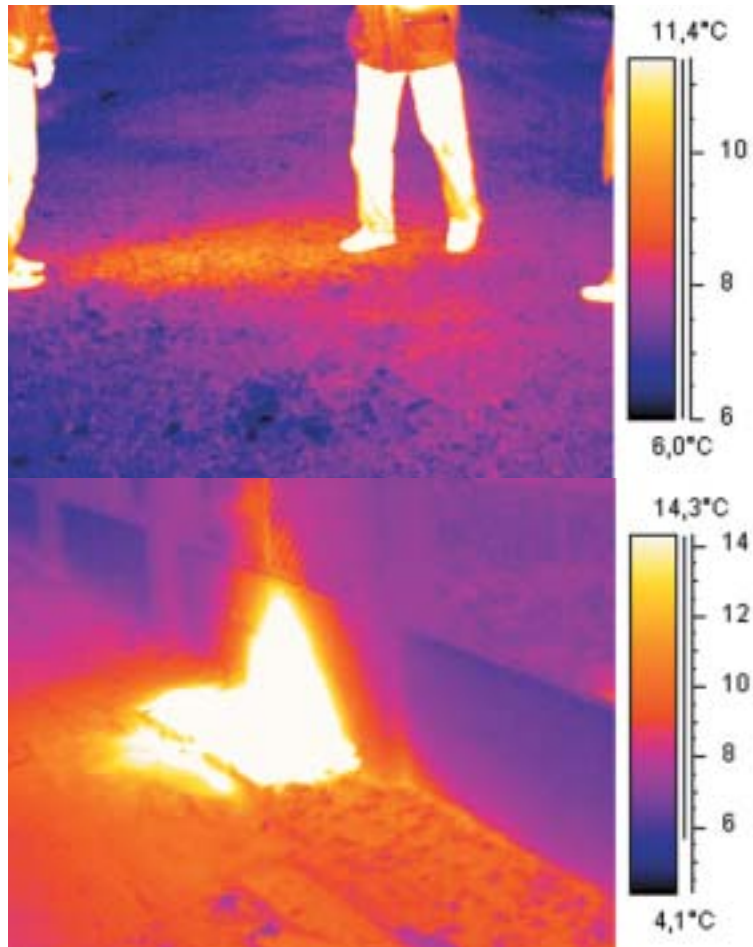
Thermal images produced by the FLIR ThermaCam provide detailed information that is invaluable to accurately locate leaks or damages in district heating networks.
